2017 Hurricane Harvey Deployment
Arkema Facility Response
8/31/2017 1:45:27 PM

***2017 ASPECT Preliminary Report
Arkema Plant Response
Crosby, TX***

***August 31, 2017
0600 hrs to 1300 hrs***

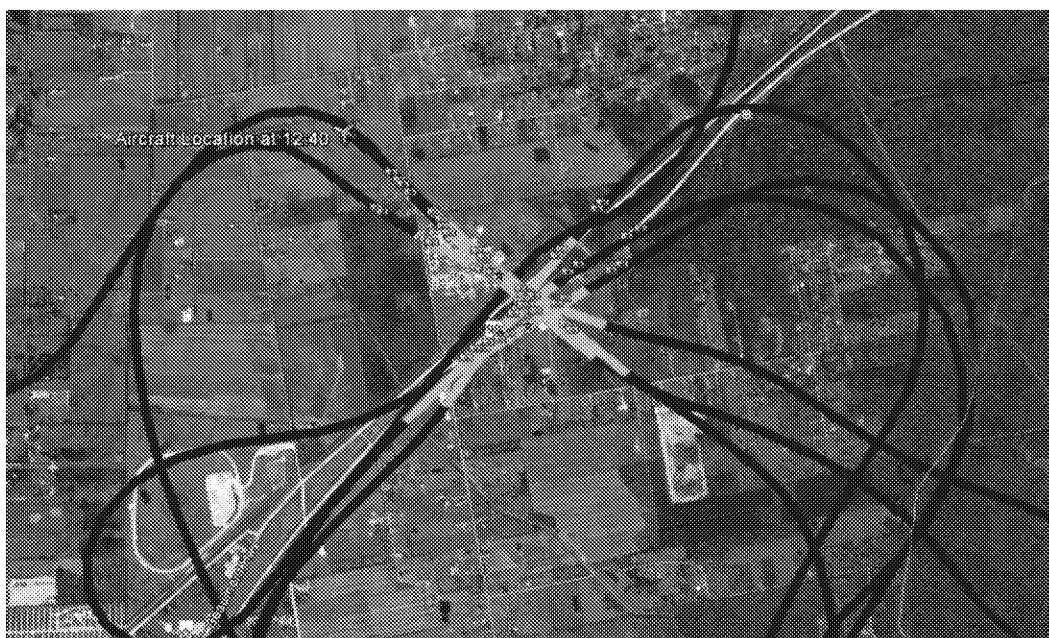
Figure 7: Flight path over the facility at 0731 hrs CST (1231 hrs UTC) showing several passes where aerial imagery and IR sensors were active.
